JUPITER ICY MOONS ORBITER

LESSONS LEARNED NEWSLETTER

SPOTLIGHT: First Issue of the JIMO Lessons Learned Newsletter

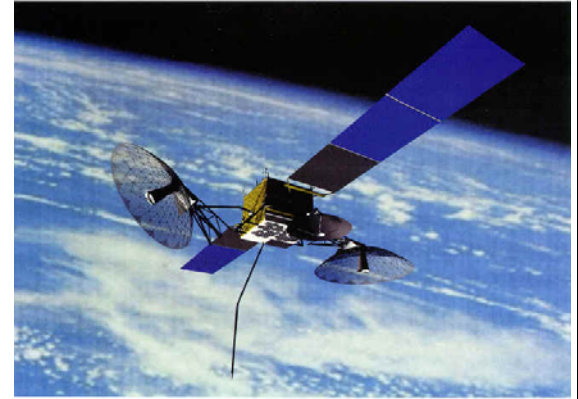
Abstract: The TDRS-H was launched on June 30, 2000 incorporated a number of new communication technologies including the Single Access Springback Reflector Antenna, transmitters and receivers operating at Ka-band and the S-band microstrip patch antenna elements used in the Multiple Access (MA) phase arrays. During In-Orbit Test (IOT), performance deficiencies were observed in the MA forward (MAF) and return (MAR) channels. Performance testing of individual return array elements was initiated revealing widely divergent gain and axial ratios for the elements when compared to pre launch factory measurements. BSS initiated a comprehensive anomaly investigation incorporating: 1) On-orbit testing of TDRS-H; 2) Laboratory performance investigation of flight MA antenna elements; and 3) Factory satellite system level MA testing using the TDRS-I then undergoing integration and test. Ultimately, BSS determined that the most probable cause of the observed performance was due to the MA array sunshield (thermal blanket) coming into contact with the antenna array elements. Such contact creates a dielectric loading of the microstrip patch radiators and transmission lines altering the phase relationship of the radiators and shifting the resonant frequency of the elements. Altering the phase relationship causes the element gain pattern to "squint" or move off axis by some 8 degrees. The peak directivity, resistive loss and VSWR (Voltage Standing Wave Ratio) performance of the MA antenna elements degraded as a result of the close proximity of the sunshield. The sunshield is held in contact with the elements by electrostatic force created by deep charging of the dielectric materials used in the construction of the antenna elements. In response, a negative "image" charge appears in the sunshield (since it is conductive and grounded), and the electrostatic attractive force field is created.

- The use of microstrip patch elements was a new design to BSS, and as such, received substantial attention during the design, development and test phase. However, the interrelated physics of the sunshield contact and performance shortfall were never fully understood.
- Designers assumed that the designed spacing between the elements and the sunshield would be achieved. (The designed spacing of approximately 1/2 inch is more than sufficient to eliminate the effect.)
- Designers of the sunshield mechanical retention were unaware of the electrostatic attraction force and assumed that the sunshield would maintain clearance in the zero gravity space environment.

1. The design was altered to include standoffs over each forward and return antenna element. The standoffs assure a minimum separation of the element and the sunshield to avoid the RF performance impact.
2. Specific tests of TDRS-I were incorporated to determine if an individual element were exhibiting performance similar to one with a sunshield in forcible contact.
3. The entire TDRS-I system is tested in the final flight configuration.
